## BLM Cedar City Field Office Site Inspection Report

May 29, 2009

File: UTU-67116  
Hecla Mining Company  
Escalante Mine Tailings Impoundment

Inspector: Ed Ginouves, CCFO Mining Engineer

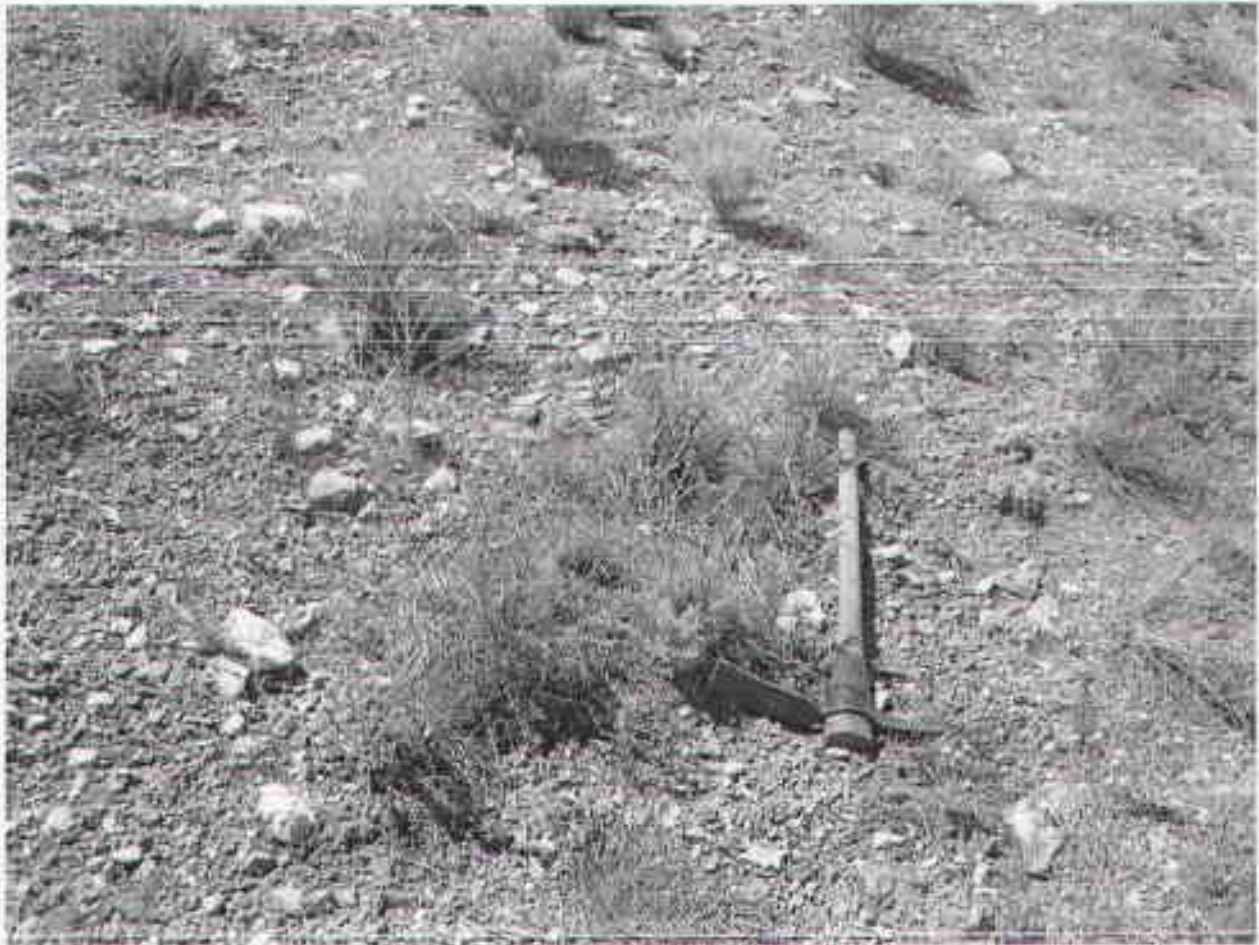
**UTU-67116: Escalante Mine Tailings Impoundment  
May 28, 2009**

**Inspection Findings:** I parked the vehicle at the east gate and walked to the southern edge of the impoundment, where the bulk of the knapweed had been historically found. I searched the diversion ditch area and adjacent slopes all the way to west gate (which was still wired close). To my disappointment, I found ~ 50 plants, virtually all of which were in clusters of several plants on the north facing slope adjacent to the diversion ditch. All of the plants were in the juvenile stage and I destroyed them by uprooting. Hecla employees/ contractors must have visited the site within the last week or so as evidenced by fresh footprints in the ditch bottom and drooping of some of the knapweed plants due to being sprayed with herbicide. Most of the plants I uprooted showed no signs of having been sprayed and must have been missed by the sprayers. The presence of the plants evidences that the site can't be released yet again.

**Cluster of juvenile knapweed plants on slope adjacent to diversion ditch in southeast corner of impoundment.**

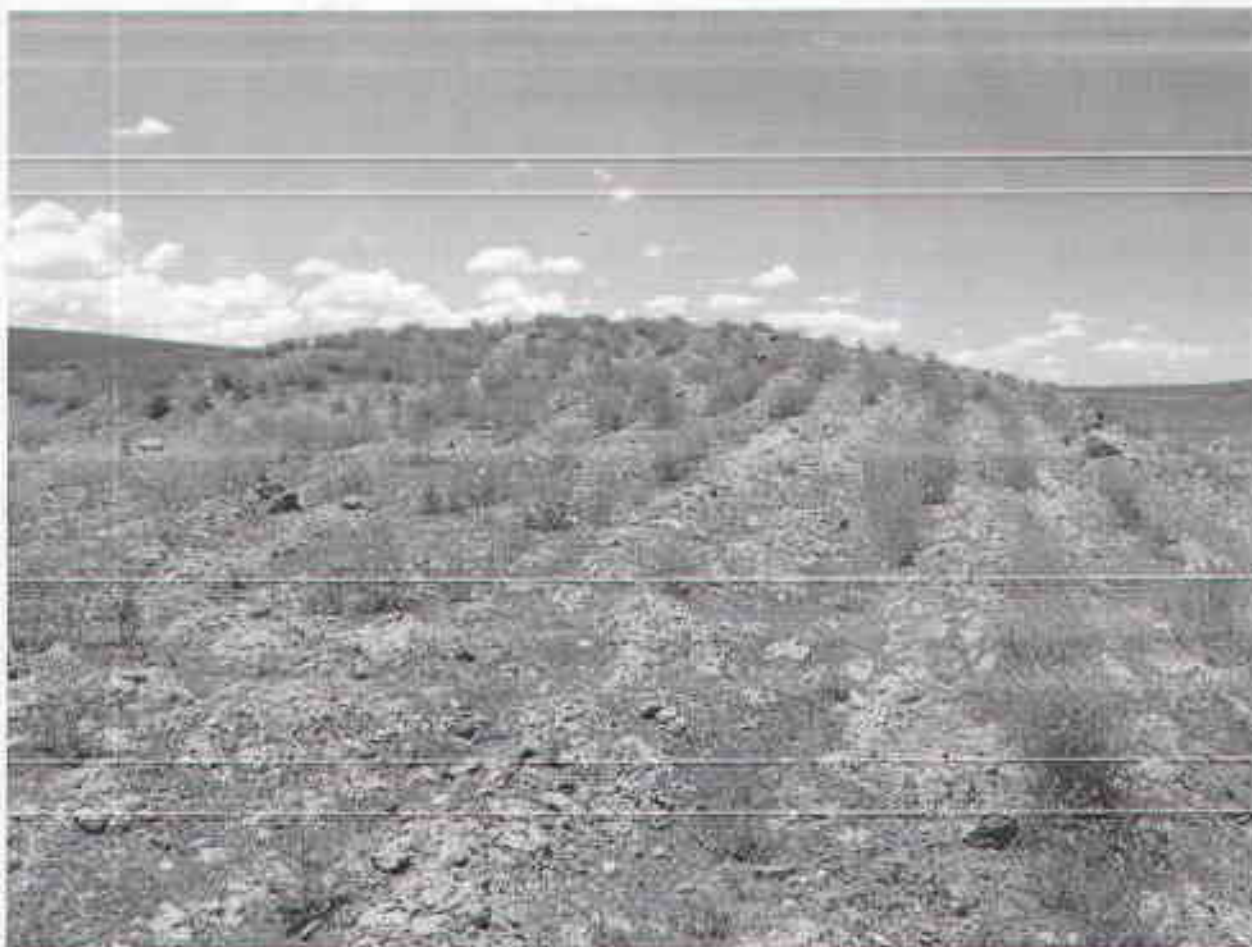
**UTU-67116: Escalante Mine Tailings Impoundment**  
**May 28, 2009**

The vegetative cover on the reclaimed low-grade stockpile (on private land near the mill) is little changed from last year; the predominate species present are mustard, hoarhound, cheatgrass, Russian thistle. Some wheatgrass was present by estimated to be < 1% of the vegetative cover.

**View, looking westerly, along the crest of the reclaimed low-grade stockpile area (private land).  
Vegetation visible is mustard.**
